Summit Hill School District 161

Project Number: 21-030

2021 Facility Assessment Update

Updated: September 15, 2021

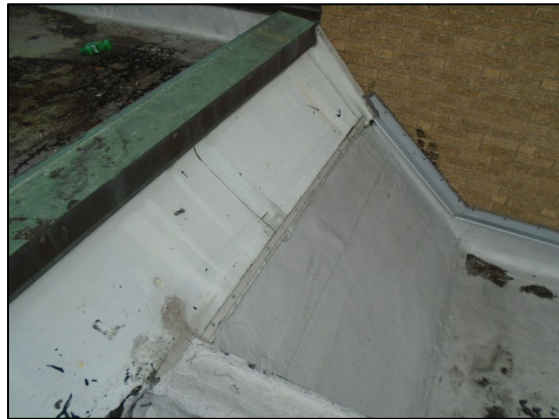
AH 46	Y	Arbury Hills	Envelope	Cracked and depressed sidewalk around building - typical	Recommended	1
AH 49	N	Arbury Hills	Roof	Gap/damage in flashing - sections 7, 4	Recommended	1
AH 53	N	Arbury Hills	Roof	Crack at coping seam - section 4	Recommended	1
AH 56	N	Arbury Hills	Roof	Missing pipe supports - section 4	Recommended	1
AH 57	N	Arbury Hills	Roof	Seam flashing reinforcing is exposed - section 4	Recommended	1
AH 58	N	Arbury Hills	Roof	Loose/damaged roof drain dome - section 4	Recommended	1
AH 59	N	Arbury Hills	Roof	Roof membrane cracking and soft spot in insulation at roof drain - section 7	Recommended	1
AH 60	N	Arbury Hills	Roof	Deteriorated pitch pocket pipe penetration - section 8	Recommended	1
AH 62	N	Arbury Hills	Roof	Damaged trim on wall above roof - section 9	Recommended	1
AH 63	Y	Arbury Hills	Roof	Surface cracking (partial recoat) - section 9	Recommended	1
AH 65	N	Arbury Hills	63,66,70 additions	Replace HVAC system Mech. Not appropriate for schools	Recommended	1

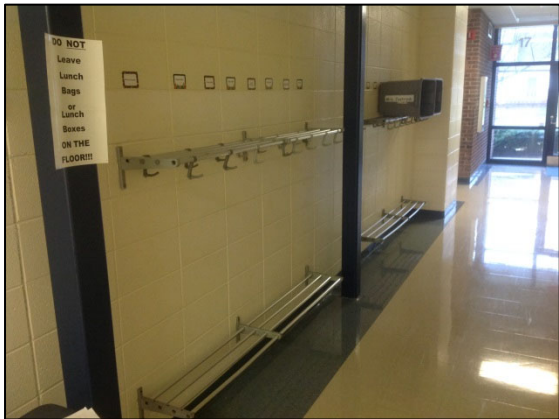
FS 3	Y	Frankfort Square	101A	Update lighting	Recommended	3	9, 16	Architect	E, F	H	C		SF	200	\$2,500.00	2					
FS 4	Y	Frankfort Square	All	Replace open coat hooks with cubbies	Recommended	3	11	Architect	F	G, H	I	Prevent spread of lice	LS	1	\$25,000.00	2					
FS 23	N	Frankfort Square	113	Upgrade lighting	Recommended	3	16	Architect	F	B, H	H		LS	1	\$20,000.00	2					
FS 29	Y	Frankfort Square	Envelope	Damaged and faded exterior hollow metal doors and frames - typical	Recommended	3	8	Architect	C	H	H		EA	17	\$12,750.00	2					
FS 31	N	Frankfort Square	Envelope	Single pane windows - typical	Recommended	3	8	Architect	F	B	H		EA	8	\$12,000.00	2					
FS 32	N	Frankfort Square	Envelope	Damaged louver - north elevation	Recommended	3	15	Architect	F	H	H		EA	1	\$250.00	2					
FS 35	N	Frankfort Square	Envelope	Open joints at weeps - typical	Recommended	3	4	Architect	C	H	C		LS	1	\$10,000.00	2					
FS 40	N	Frankfort Square	Roof	Poor coping detail at corner - section 2	Recommended	3	7	Architect	C	H	C		LS	1	\$300.00	2

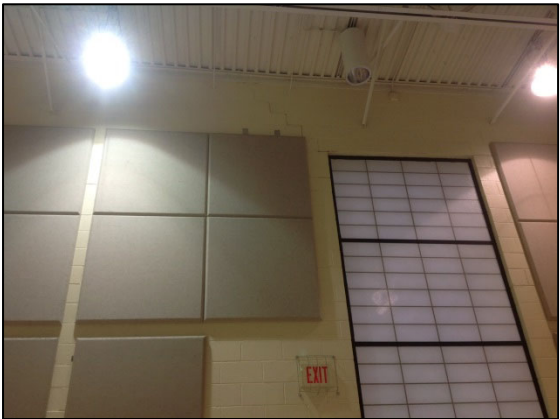
FS 21	Y	Frankfort Square	117, 118	Masonry crack	Recommended	M	4	Architect	C	H	B		LS	1	\$500.00	3		2017	District in-house	7/30/18 DW	
FS 24	Y	Frankfort Square	113	Masonry crack	Recommended	M	4	Architect	C	H	B		LS	1	\$500.00	3		2017	District in-house	7/30/18 DW	
FS 24A	Y	Frankfort Square	113	Masonry crack	Recommended	M	4	Architect	C	H	B		LS	1	\$500.00	3		2017	District in-house	7/30/18 DW	
FS 33	Y	Frankfort Square	Envelope	No sealant at conduit through wall - west elevation	Recommended	M	15	Architect	C	H	H		EA	1	\$100.00	3		2017	District in-house	7/30/18 DW

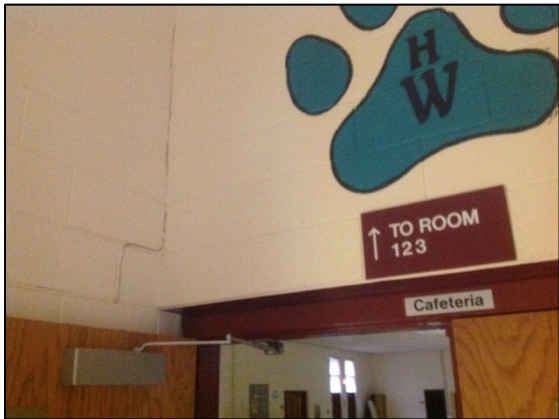
HW 106	N	Hilda Walker	PE	Office - the sink works some of the time	Recommended	3
HW 135	N	Hilda Walker	Gym	Replace bleachers	Recommended	3
HW 4	Y	Hilda Walker	Door #14	Rusted HVAC Cover	Recommended	M
HW 5	Y	Hilda Walker	121	Masonry Crack	Recommended	M
HW 6	Y	Hilda Walker	117	Damaged floor	Recommended	M
HW 10	Y	Hilda Walker	121	Masonry Crack	Recommended	M

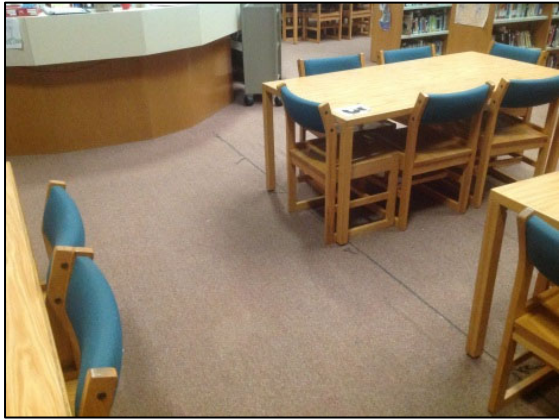
HW 28	Y	Hilda Walker	Center Stairwell	Stair tread repair needed	Urgent	1	9	Architect	C	A	D		LS	1	\$3,500.00	2		2017	District in-house	7/30/18 DW	
HW 29	Y	Hilda Walker	127	Replace carpeting	Recommended	1	9	Architect	C	A, H	H		SF	3000	\$10,000.00	2					
HW 46	Y	Hilda Walker	129	Replace carpeting	Recommended	1	9	Architect	C	A, H	H		SF	800	\$2,500.00	2					
HW 50	Y	Hilda Walker	139	Carpet worn and stained	Recommended	1	9	Architect	C	A, H	H		SF	800	\$2,500.00	2		2021		9/2/21 TRS	
HW 63	Y	Hilda Walker	Envelope	Areas of sidewalk have settled - typical	Recommended	1	2	Architect	C	A	H	Tripping hazard	SF	108	\$800.00	2					
HW 65	Y	Hilda Walker	Envelope	Exposed membrane flashing - typical	Recommended	1	4	Architect	C	H	C	Cut off	LS	1	\$1,600.00	2					
HW 67	N	Hilda Walker	Envelope	Replace backer rod and sealant at control joint - south, west elevation	Recommended	1	4	Architect	C	H	H		EA	5	\$1,250.00	2
