Summit Hill School District 161

Project Number: 21-030

2021 Facility Assessment Update

Updated: September 15, 2021

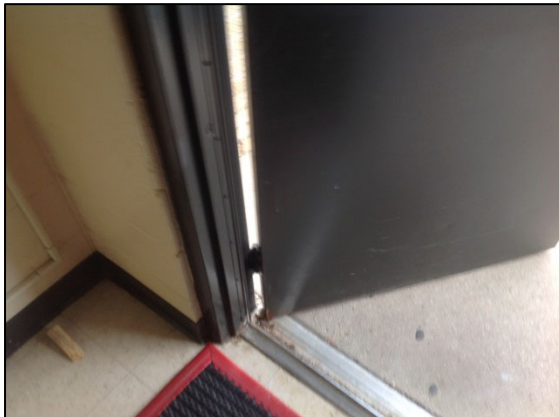
AH 16	Y	Arbury Hills	Door #18	Rusted frame	Recommended	2	8	Architect	C, F	B, G	H		EA		\$2,500.00	2					
AH 17	Y	Arbury Hills	Near 130D	Excessive open storage	Recommended	2	6	Architect	F	A, H	C		LS		\$5,000.00	3		2017	District in-house	7/30/18 DW	
AH 19	Y	Arbury Hills	130	Replace ceiling	Recommended	2	9	Architect	F	H	H		SF	1200	\$9,000.00	3					
AH 55	N	Arbury Hills	Roof	Bubble in roof membrane - typical	Recommended	2	7	Architect	C	H	H		LS	1	\$360.00	2					
AH 61	N	Arbury Hills	Roof	Depressions in roof surface that cause ponding water - typical	Recommended	2	7	Architect	C	H	H	Fix depressions and recoat roof areas	LS	1	\$3,500.00	2					
AH 64	N	Arbury Hills	Entire building	Plumbing piping galvanized	Recommended	2	15	Engineer	F	H	H		LS	1	\$124,800.00	2					
AH 66	N	Arbury Hills	63, 66 Addition	Electrical panels obsolete	Recommended	2	16	Engineer	F	H	H		LS	1	\$35,000.00	2					
AH 68	N	Arbury Hills	Entire building	No occupancy sensors	Recommended	2	16	Engineer	F	L - energy code	E		LS	1	\$9,000.00	2	Grant money available

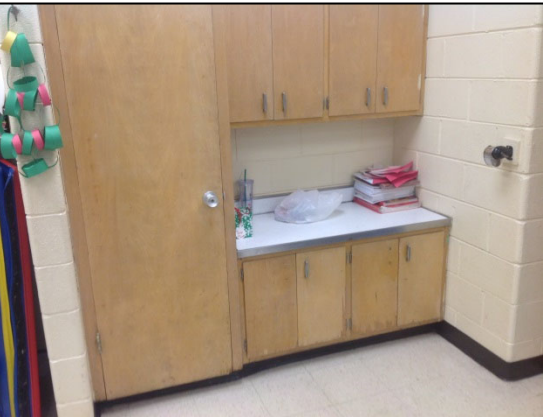
AH 5	Y	Arbury Hills	129	Various mechanical room hazards	Urgent	1
AH 8	N	Arbury Hills	All	Upgrade classroom mechanical system	Recommended	1
AH 13	N	Arbury Hills	Exterior	Add fencing near new retention pond	Recommended	1
AH 22	Y	Arbury Hills	117-122	Cabinets worn	Recommended	1
AH 23	Y	Arbury Hills	117	Replace interior window	Recommended	1
AH 24	Y	Arbury Hills	119, 120, 123	Replace windows - no screens, single glazed	Recommended	1
AH 28	Y	Arbury Hills	115	Apply new film over window to control sun, heat	Recommended	1
AH 38	Y	Arbury Hills	Envelope	Tuckpoint joints and replace spalling masonry - typical	Recommended	1
AH 40	Y	Arbury Hills	Envelope	Damaged stone in band - north elevation	Recommended	1
AH 41	Y	Arbury Hills	Envelope	Damaged joint in stone band - north elevation	Recommended	1
AH 42	Y	Arbury Hills	Envelope	Repair/extend discharge piping away from wall of building - north and south elevations	Recommended	1

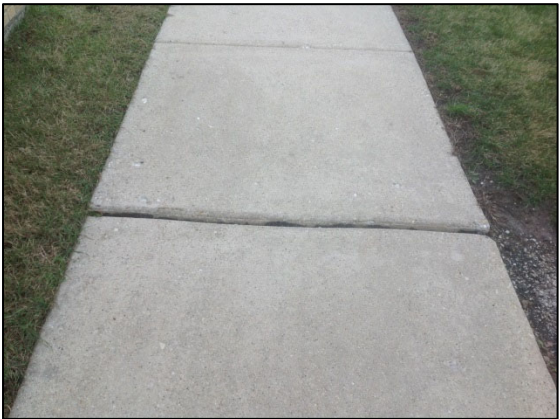
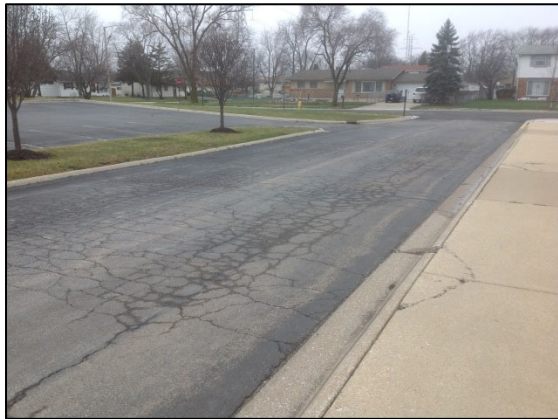
AH 46	Y	Arbury Hills	Envelope	Cracked and depressed sidewalk around building - typical	Recommended	1
AH 49	N	Arbury Hills	Roof	Gap/damage in flashing - sections 7, 4	Recommended	1
AH 53	N	Arbury Hills	Roof	Crack at coping seam - section 4	Recommended	1
AH 56	N	Arbury Hills	Roof	Missing pipe supports - section 4	Recommended	1
AH 57	N	Arbury Hills	Roof	Seam flashing reinforcing is exposed - section 4	Recommended	1
AH 58	N	Arbury Hills	Roof	Loose/damaged roof drain dome - section 4	Recommended	1
AH 59	N	Arbury Hills	Roof	Roof membrane cracking and soft spot in insulation at roof drain - section 7	Recommended	1
AH 60	N	Arbury Hills	Roof	Deteriorated pitch pocket pipe penetration - section 8	Recommended	1
AH 62	N	Arbury Hills	Roof	Damaged trim on wall above roof - section 9	Recommended	1
AH 63	Y	Arbury Hills	Roof	Surface cracking (partial recoat) - section 9	Recommended	1
AH 65	N	Arbury Hills	63,66,70 additions	Replace HVAC system Mech. Not appropriate for schools	Recommended	1

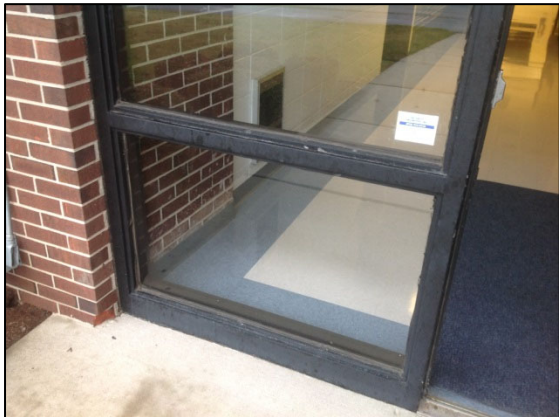
FRANKFORT SQUARE SCHOOL (FS)																						
FS 8	Y	Frankfort Square	Door #12 - #17	Replace door/frame	Recommended	1	8	Architect	E, F	A, B, C, D, G	B, H		EA	6	\$40,000.00	2						
FS 25	Y	Frankfort Square	Envelope	Spalling and cracking face brick - typical	Recommended	1	4	Architect	C	H	C		LS	1	\$9,500.00	2						
FS 27	Y	Frankfort Square	Envelope	Replace backer rod and sealant at control joints - typical	Recommended	1	4	Architect	C	H	H		EA	4	\$1,000.00	2						
FS 28	N	Frankfort Square	Envelope	Rust on lintel - west elevation	Recommended	1	5	Architect	C	H	H		EA	1	\$500.00	2						
FS 34	N	Frankfort Square	Envelope	Warped steel lintel above door - west elevation	Recommended	1	5	Architect	C	H	H		EA	1	\$1,200.00	2						
FS 36	Y	Frankfort Square	Envelope	Damaged soffit or fascia - typical	Recommended	1	4	Architect	F	A	H	Replace all soffit & fascia	LS	1	\$110,000.00	2						
FS 38	N	Frankfort Square	Envelope	Exposed membrane flashing at base of wall - typical	Recommended	1	4	Architect	C	H	C	Cut off exposed	LS	1	\$1,600.00	2

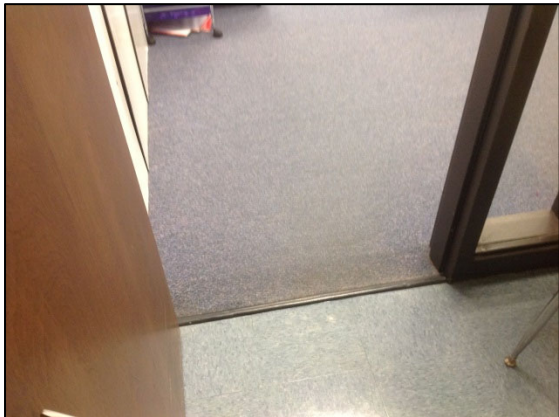
FS 6	Y	Frankfort Square	147, 148	Replace carpeting	Recommended	2	9	Architect	E, F	H	H		SF	1800	\$6,000.00	2					
FS 9	N	Frankfort Square	143	May require a rated door/frame	Recommended	2	8	Architect	E, F	G	A		EA	1	\$2,500.00	1					
FS 11	Y	Frankfort Square	141	Replace carpeting	Recommended	2	9	Architect	E	H	H		SF	900	\$3,000.00	2					
FS 14	Y	Frankfort Square	127	Library desk is not proper ADA height	Recommended	2	6	Architect	E	C, H	C		EA	1	\$4,000.00	2					
FS 20	Y	Frankfort Square	124, 125	Replace carpeting	Recommended	2	9	Architect	E, F	H	H		SF	1800	\$6,000.00	3					
FS 22	Y	Frankfort Square	Near 113	Replace VCT floor in wet area	Recommended	2	9	Architect	F	A, H	C		SF	50	\$250.00	3		2021		9/2/21 MK	
FS 26	N	Frankfort Square	Envelope	Tuckpoint masonry - typical	Recommended	2	4	Architect	C	H	H		LS	1	\$750.00	2					
FS 30	Y	Frankfort Square	Envelope	Brick sills - typical	Recommended	2	1	Architect	C	H	C	Replace with stone sills	EA	8	\$5,200.00	2

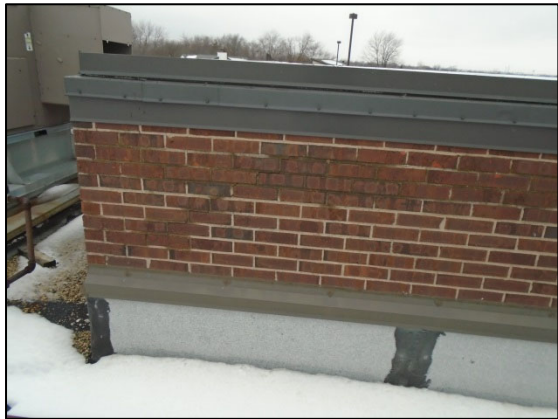
FS 42	N	Frankfort Square	Roof	Bubble in roof membrane - section 1, gym	Recommended	2	7	Architect	C	H	H		LS	1	\$180.00	2					
FS 52	Y	Frankfort Square	Roof	Tuckpoint wall above roof - section 4	Recommended	2	4	Architect	C	H	H		LS	1	\$800.00	2					
FS 54	N	Frankfort Square	Roof	Roof drain appears inadequate - section 4	Recommended	2	7	Architect	C	H	C		LS	1	\$5,000.00	2					
FS 61	Y	Frankfort Square	Roof	Roof curb too low - section 4	Recommended	2	7	Architect	F	H	C		LS	1	\$1,200.00	2					
FS 64	N	Frankfort Square	74, 76 additions	Domestic water piping galvanized	Recommended	2	15	Engineer	F	B, H	H		LS	1	\$60,500.00	2					
FS 66	N	Frankfort Square	Entire building	No occupancy sensors	Recommended	2	16	Engineer	F	B	I - energy code		LS	1	\$7,200.00	2	Grant money available				
FS 67	N	Frankfort Square	74, 76, 81	Plumbing fixtures beyond life expectancy	Recommended	2	15	Engineer	F	C, H	H		LS	1	\$45,000.00	2

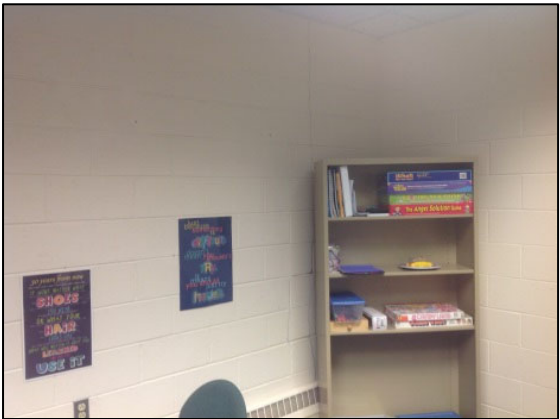
HW 59	Y	Hilda Walker	202	Masonry Crack	Recommended	M	4	Architect	C	H	B		LS	1	\$500.00	3		2017	District in-house	7/30/18 DW	
HW 60	Y	Hilda Walker	Near 202	Stair doors removed, interior vestibule door is rated, but has large gap at base	Recommended	M	8	Architect	F	A	C		LS	1	\$300.00	1					
HW 61	N	Hilda Walker	207B	Drinking fountain does not work	Recommended	M	15	Architect	C	H	B		LS	1	\$3,000.00	3		2017	District contractor	7/30/18 DW	
HW 62	N	Hilda Walker	Near Elevator	Drinking fountain overshoots onto carpet below	Urgent	M	1	Architect	C	H	B		LS	1	\$0.00	3		2016	District in-house	7/30/18 DW	
HW 64	Y	Hilda Walker	Envelope	Mulch above wall base flashing - typical	Recommended	M	2	Architect	B	F	C		LS	1	\$500.00	3					
HW 66	N	Hilda Walker	Envelope	Open exterior electrical box - south elevation	Urgent	M	16	Architect	C	A	B		LS	1	\$50.00	3		2017	District in-house	7/30/18 DW	
HW 68	N	Hilda Walker	Envelope	Grade is above wall base flashing - south elevation	Recommended	M	2	Architect	B	H	C		LS	1	\$500.00	3		2017	District in-house	7/30/18 DW

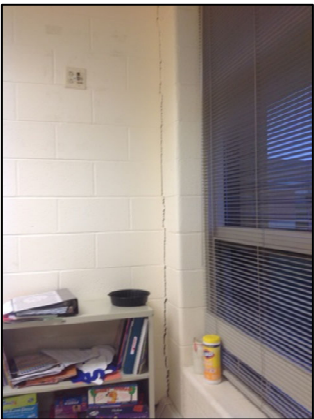
Item/Picture ID	Photo (Y/N)	School	Location	Description	Priority Code to Resolve: (Urgent, Recommended)	Completion Target Dates
DR. JULIAN ROGUS SCHOOL (JR)						
JR 4	Y	Julian Rogus	172-196	Crack in masonry	Recommended	1
JR 7	Y	Julian Rogus	186A	Very bad ceiling tile damage. Very loud mechanical overhead.	Recommended	1
JR 25	Y	Julian Rogus	Envelope	Through-wall membrane flashing exposed - south elevation	Recommended	1
JR 26	N	Julian Rogus	Envelope	Mortar washed out at base of wall - south elevation	Recommended	1
JR 28	Y	Julian Rogus	Envelope	No light fixture at exterior doors - typical	Recommended	1
JR 29	N	Julian Rogus	Envelope	Soffit panel missing - north elevation	Recommended	1
JR 30	N	Julian Rogus	Envelope	Through-wall flashing drip edge is loose from wall - east elevation	Recommended	1
JR 32	N	Julian Rogus	Envelope	Loose mortar under stone sill - west elevation	Recommended	1
JR 33	N	Julian Rogus	Envelope	Exposed wood shim under stone sill - west elevation	Recommended	1

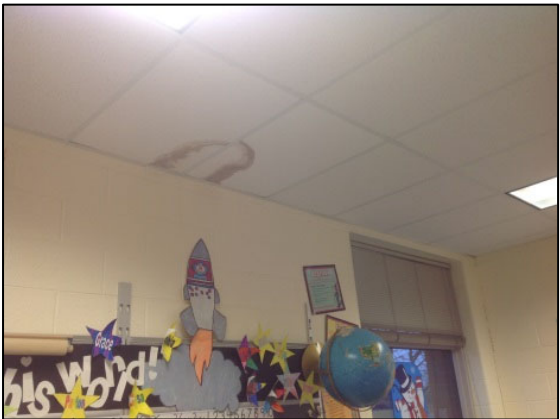
JR 5 & JR 6

JR 59	N	Julian Rogus	Boiler room	3 - boilers need replacement	Recommended	1
JR 61	N	Julian Rogus	Entire building	Retro Commission HVAC & PLBG	Recommended	1
JR 62	N	Julian Rogus	Entire building	Control issues	Recommended	1
JR 5	Y	Julian Rogus	Entire Building	Roof leak at ceiling typical	Recommended	2

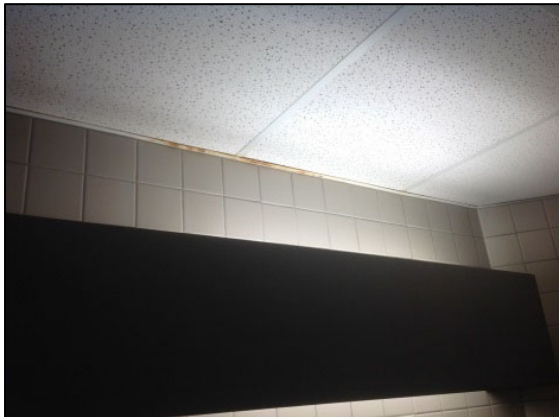
JR 8	Y	Julian Rogus	183	Rusted ceiling grid	Recommended	2	9	Architect	E, F	H	C, D		SF	200	\$2,200.00	2					
JR 14	Y	Julian Rogus	112-135	Replace damaged flooring near drinking fountain	Recommended	2	9	Architect	F	A, H	C		EA	16	\$800.00	2					
JR 20	Y	Julian Rogus	101	Crack in floor tile	Recommended	2	9	Architect	C	H	C, D		SF	25	\$400.00	2					
JR 23	N	Julian Rogus	Envelope	Rust on gym doors - south elevation	Recommended	2	8	Architect	C	H	H		LS	1	\$1,500.00	2					
JR 24	N	Julian Rogus	Envelope	Rust on lintel above door - south elevation	Recommended	2	5	Architect	C	H	H		LS	1	\$500.00	2					
JR 39	Y	Julian Rogus	Roof	Non-recommended flashing detail	Recommended	2	7	Architect	C	H	C	See JR 52				2		2017	16-062	07/11/2017-NG	
JR 46	Y	Julian Rogus	Roof	Significant wear on cap sheet	Recommended	2	7	Architect	C	H	H	Recoat roof areas	SF	45000	\$135,000.00	2					
JR 60	N	Julian Rogus	Entire building	No occupancy sensors	Recommended	2	16	Engineer	F	B	I - energy		LS	1	\$25,000.00	2	Grant money available

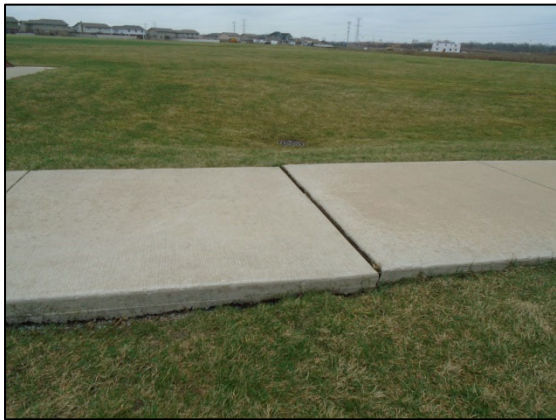
JR 34	Y	Julian Rogus	Envelope	Sidewalk uneven at seam - east elevation	Recommended	1
JR 35	N	Julian Rogus	Roof	Missing roof drain dome	Recommended	1
JR 36	N	Julian Rogus	Roof	Cracks in flashing membrane	Recommended	1
JR 41	Y	Julian Rogus	Roof	Exposed nail heads on ridge shingles	Recommended	1
JR 43	Y	Julian Rogus	Roof	Cracks in flashing at pipe support curb	Recommended	1
JR 45	Y	Julian Rogus	Roof	Membrane flashing exposed in wall above roof	Recommended	1
JR 48	N	Julian Rogus	Roof	Cracking in flashing	Recommended	1
JR 49	N	Julian Rogus	Roof	Flashing loose at roof drain	Recommended	1
JR 51	N	Julian Rogus	Roof	Loose caps at exhaust fans	Recommended	1
JR 52	Y	Julian Rogus	Roof	Shingles not properly adhered to lower shingles	Recommended	1
JR 53	Y	Julian Rogus	Roof	Shingles appear to be improperly staggered	Recommended	1
JR 54	Y	Julian Rogus	Roof	No valley flashing visible	Recommended	1
JR 55	N	Julian Rogus	Roof	Loose ridge shingles	Recommended	1

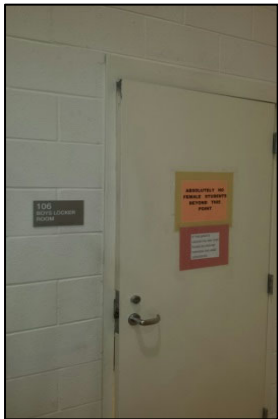
SUMMIT HILL JUNIOR HIGH SCHOOL (SH)																					
SH 4	Y	Summit Hill Junior High	104, 111	Locker room doors will not close	Recommended	1	8	Architect	C, E	D, H	B, G		EA	2	\$5,000.00	2		2021		9/2/21 TRS	
SH 11	Y	Summit Hill Junior High	108, 109, 144, 146	Poor floor transition	Recommended	1	9	Architect	E, F	A, H	C		EA	4	\$1,600.00	2					
SH 25	Y	Summit Hill Junior High	Envelope	Replace backer rod and sealant at control joint - west, north elevation	Recommended	1	4	Architect	C	H	H		EA	4	\$2,000.00	2					
SH 28	Y	Summit Hill Junior High	Envelope	Water damage at soffit - east elevation	Recommended	1	9	Architect	C	H	F		LS	1	\$3,600.00	2					
SH 29	Y	Summit Hill Junior High	Envelope	Through-wall flashing membrane is exposed - typical	Recommended	1	4	Architect	C	H	C	Cut off	LS	1	\$3,200.00	2					
SH 31	Y	Summit Hill Junior High	Envelope	Cracking in concrete foundation - west elevation	Recommended	1	3	Architect	C	H	H		LS	1	\$1,500.00	2		2021		9/2/21 TRS

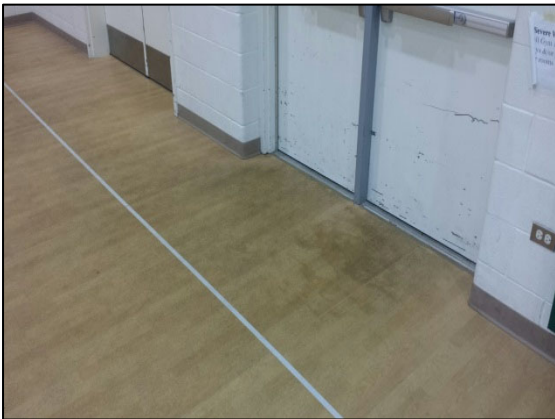
SH 3	N	Summit Hill Junior High	Door #12	Will not close on its own	Recommended	M	8	Architect	C	D, H	B		LS	1	\$800.00	3		2021		9/2/21 TRS	
SH 5	Y	Summit Hill Junior High	111	Floor damage	Recommended	M	9	Architect	C	H	A, B	Attempt to clean first	LS	1	\$200.00	3					
SH 6	Y	Summit Hill Junior High	111	Fix mat	Recommended	M	10	Architect	C	A, H	B, G		LS	1	\$200.00	3		2017	District in-house	7/30/18 DW	
SH 7	Y	Summit Hill Junior High	118	Roof leaks	Recommended	M	7, 9	Architect	C	H	B		LS	1	\$0.00	3		2016	District in-house	7/30/18 DW	
SH 9	Y	Summit Hill Junior High	121	Carpet stained	Recommended	M	9	Architect	C	H	F		LS	1	\$0.00	3		2017	District in-house	7/30/18 DW	
SH 12	Y	Summit Hill Junior High	108	Ceiling stained	Recommended	M	9	Architect	C	H	B		LS	1	\$0.00	3		2017	District in-house	7/30/18 DW	
SH 13	Y	Summit Hill Junior High	122	Carpet stain	Recommended	M	9	Architect	C	H	F		LS	1	\$100.00	3		2017	District in-house	7/30/18 DW

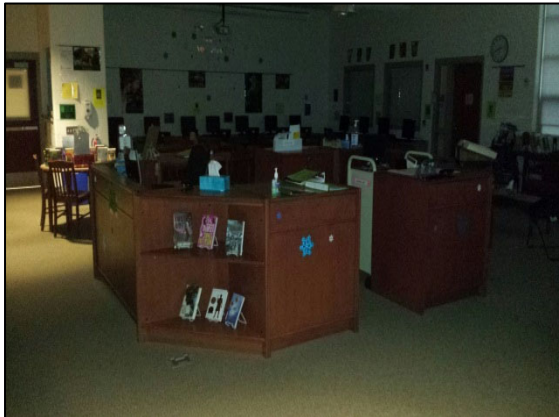
SH 14	Y	Summit Hill Junior High	124	Media center desk not ADA	Recommended	3	6	Architect	E, F	G	C		LS	1	\$2,000.00	2					
SH 26	Y	Summit Hill Junior High	Envelope	Organic growth on window sill - north elevation	Recommended	3	4	Architect	C	H	H	Clean sills	LS	1	\$750.00	2		2021		9/2/21 TRS	
SH 34	N	Summit Hill Junior High	Roof	Low spot in roof adjacent to exhaust fan curb	Recommended	3	7	Architect	C	H	C		LS	1	\$1,500.00	2					
SH 42	N	Summit Hill Junior High	Roof	Gap in metal counterflashing at seam	Recommended	3	7	Architect	C	H	H		LS	1	\$350.00	2					
SH 70	N	Summit Hill Junior High	Halls	Replace flooring	Recommended	3	9	Owner	F	G	H		SF	50000	\$350,000.00	2					
SH 1	Y	Summit Hill Junior High	101B	Masonry crack	Recommended	M	4	Architect	C	H	B		LS	1	\$500.00	3		2016	District in-house	7/30/18 DW	
SH 2	N	Summit Hill Junior High	104	Maintain bleacher stair treads	Recommended	M	12	Architect	C	A	H		LS	1	\$500.00	3		2017	District in-house	7/30/18 DW

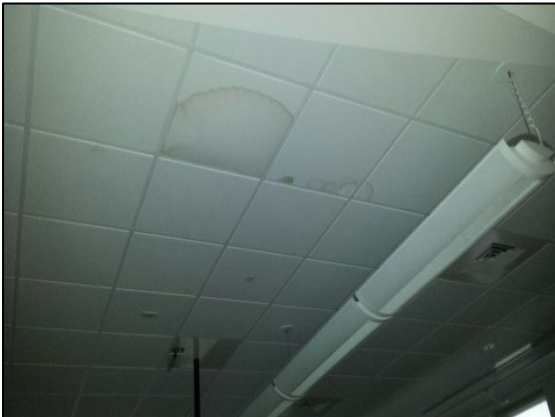
SH 15	Y	Summit Hill Junior High	124	Roof leak	Recommended	M	7, 9	Architect	C	H	B		LS	1	\$0.00	3		2016	District in-house	7/30/18 DW	
SH 16	Y	Summit Hill Junior High	152	Roof leak	Recommended	M	7, 9	Architect	C	H	B		LS	1	\$0.00	3		2017	District in-house	7/30/18 DW	
SH 17	Y	Summit Hill Junior High	201	Roof leak	Recommended	M	7, 9	Architect	C	H	B		LS	1	\$0.00	3		2017	District in-house	7/30/18 DW	
SH 18	Y	Summit Hill Junior High	201	Roof leak	Recommended	M	7, 9	Architect	C	H	B		LS	1	\$0.00	3		2017	District in-house	7/30/18 DW	
SH 19	Y	Summit Hill Junior High	Near 218	Dirty Carpet	Recommended	M	9	Architect	C	H	B		LS	1	\$100.00	3		2017	District in-house	7/30/18 DW	
SH 20	Y	Summit Hill Junior High	231	Dirty Carpet	Recommended	M	9	Architect	C	H	B		LS	1	\$100.00	3		2017	District in-house	7/30/18 DW

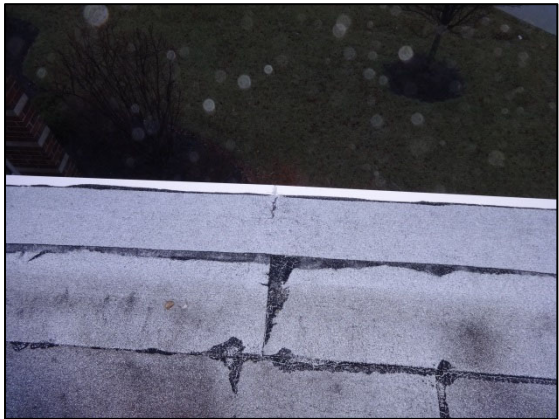
SH 33	N	Summit Hill Junior High	Roof	Exposed reinforcing in flashing at exhaust fan curb	Recommended	1	7	Architect	C	H	H		LS	1	\$350.00	2					
SH 37	Y	Summit Hill Junior High	Roof	Cracks in roof membrane at seams in gravel stop/coping	Recommended	1	7	Architect	C	H	H		LS	1	\$3,000.00	2					
SH 40	Y	Summit Hill Junior High	Roof	Replace control joint in wall above roof	Recommended	1	4	Architect	C	H	H		EA	2	\$500.00	2					
SH 41	N	Summit Hill Junior High	Roof	Loose cap sheet	Recommended	1	7	Architect	C	H	H		LS	1	\$200.00	2					
SH 43	N	Summit Hill Junior High	Roof	Crack in cap sheet at corner	Recommended	1	7	Architect	C	H	H		LS	1	\$200.00	2					
SH 44	N	Summit Hill Junior High	Roof	Cracks in roof membrane	Recommended	1	7	Architect	C	H	H		LS	1	\$400.00	2					
SH 45	Y	Summit Hill Junior High	Roof	Wrinkle in roof membrane	Recommended	1	7	Architect	C	H	H		LS	1	\$350.00	2					
SH 46	Y	Summit Hill Junior High	Roof	Cracks in flashing at coping where membrane turns 90 degrees	Recommended	1	7	Architect	C	H	H		LS	1	\$3,000.00	2

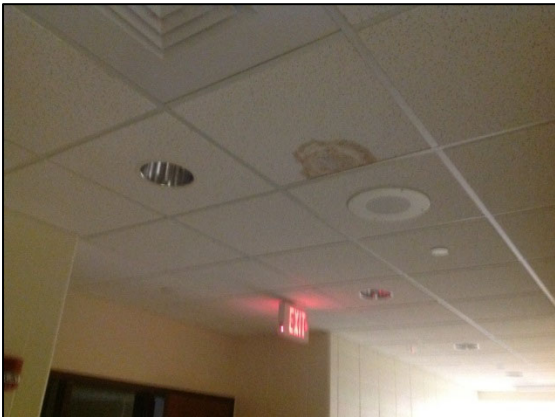
SHAC 6	Y	Summit Hill Admin Center	Hallway	Ceiling damage	Recommended	M	7, 9	Architect	C	H	B		EA	1	\$0.00	3		2017		District in-house	7/30/2018 DW	
SHAC 7	Y	Summit Hill Admin Center	149B	Ceiling damage	Recommended	M	7, 9	Architect	C	H	B		EA	1	\$0.00	3		2017		District in-house	7/30/2018 DW	
SHAC 8	Y	Summit Hill Admin Center	150	Ceiling damage	Recommended	M	7, 9	Architect	C	H	B		EA	1	\$0.00	3		2017		District in-house	7/30/2018 DW	
SHAC 9	Y	Summit Hill Admin Center	133	Ceiling damage	Recommended	M	7, 9	Architect	C	H	B		EA	1	\$0.00	3		2017		District in-house	7/30/2018 DW	
SHAC 10	Y	Summit Hill Admin Center	120	Ceiling damage	Recommended	M	9	Architect	C	H	B		LS	1	\$0.00	3		2017		District in-house	7/30/2018 DW	
SHAC 11	Y	Summit Hill Admin Center	Hallway	Ceiling damage	Recommended	M	9	Architect	C	H	B		LS	1	\$0.00	3		2017		District in-house	7/30/2018 DW	
SHAC 13	Y	Summit Hill Admin Center	Door 7	Door rusting	Recommended	M	9	Architect	E	G	H	Repaint	LS	1	\$300.00	3

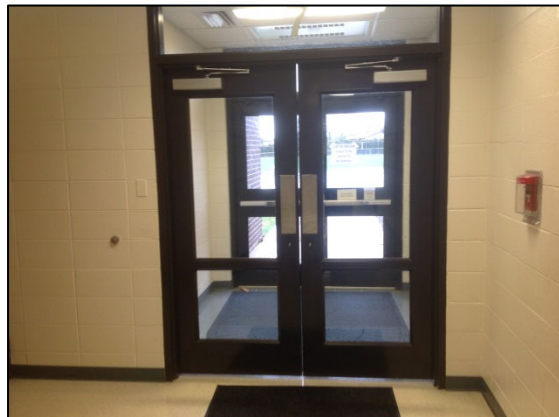
SHAC 14	Y	Summit Hill Admin Center	Door 7	Add weatherstripping	Recommended	M	8	Architect	F	B, H	D		LS	1	\$100.00	3						
SHAC 18	N	Summit Hill Admin Center	Envelope	No sweep on door - north elevation	Recommended	M	8	Architect	C	B	E		LS	1	\$100.00	3						
SHAC 22	Y	Summit Hill Admin Center	Envelope	Hole in wall at hose bib - east, south elevation	Recommended	M	4	Architect	C	H	D		LS	1	\$100.00	3		2017		District in-house	7/30/2018 DW	
SHAC 24	N	Summit Hill Admin Center	Envelope	Remove mulch above top of base flashing - typical	Recommended	M	2	Architect	B	H	C		LS	1	\$500.00	3		2017		District in-house	7/30/2018 DW	
SHAC 25	N	Summit Hill Admin Center	Envelope	No sealant at soffit panel - north elevation	Recommended	M	7	Architect	C	H	H		LS	1	\$100.00	3						
SHAC 30	Y	Summit Hill Admin Center	Roof	Stone/debris at roof drain pitch pan - section 4, 7	Recommended	M	7	Architect	C	H	H		LS	1	\$400.00	3

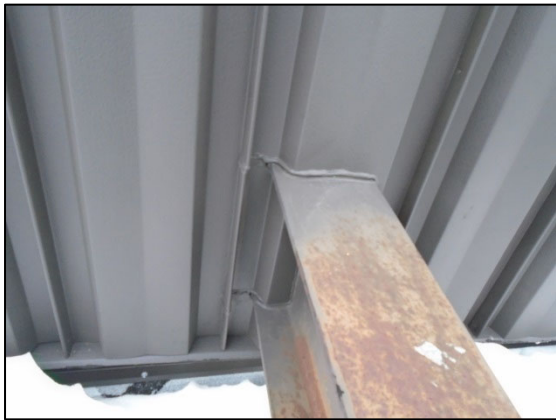
SHAC 34	Y	Summit Hill Admin Center	Roof	Inadequate sealant at wall penetrations at support beams for HVAC equipment - section 4	Recommended	M	7	Architect	C	H	D		LS	1	\$200.00	3						
SHAC 41	Y	Summit Hill Admin Center	Roof	Missing splash block at downspout above roof	Recommended	M	7	Architect	F	H	E		LS	1	\$200.00	3						
SHAC 49	N	Summit Hill Admin Center	Roof
